Space Shuttle Body Flap Actuator Bearing Testing for NASA Return to Flight

Abstract

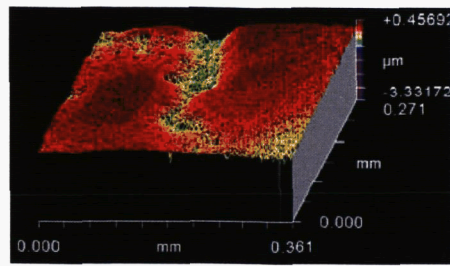
Figure 8. Surface profilometry trace showing the coating present on the black ball including a segment of the grain boundary-like structure in the center

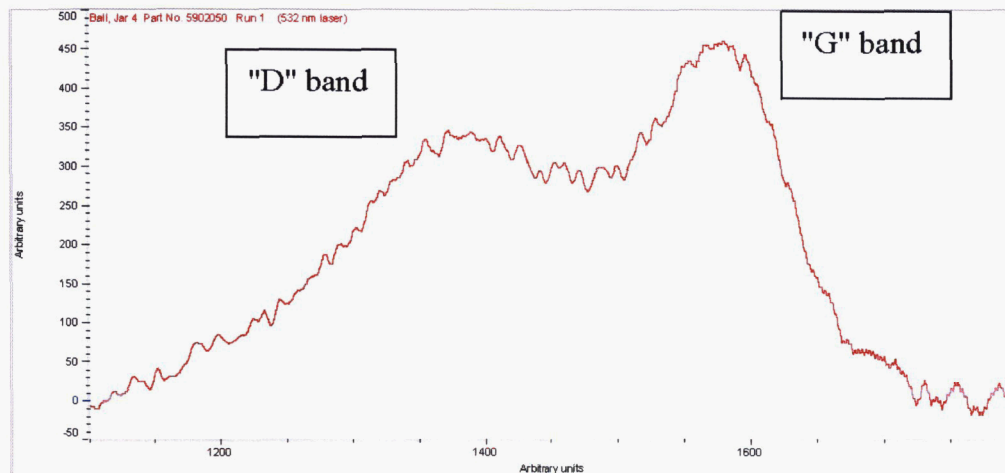
Raman spectroscopy of the black balls showed carbonaceous peaks from the carbon coating on the surface of the complex iron oxide, black, tribological coating [6]. Specifically, the diamond, D, and graphitic, G, peaks were observed confirming the presence of amorphous carbon (Figure 9).

Figure 9. Raman spectrum for black ball showing the graphitic (G) and diamond (D) peaks associated with amorphous carbon.

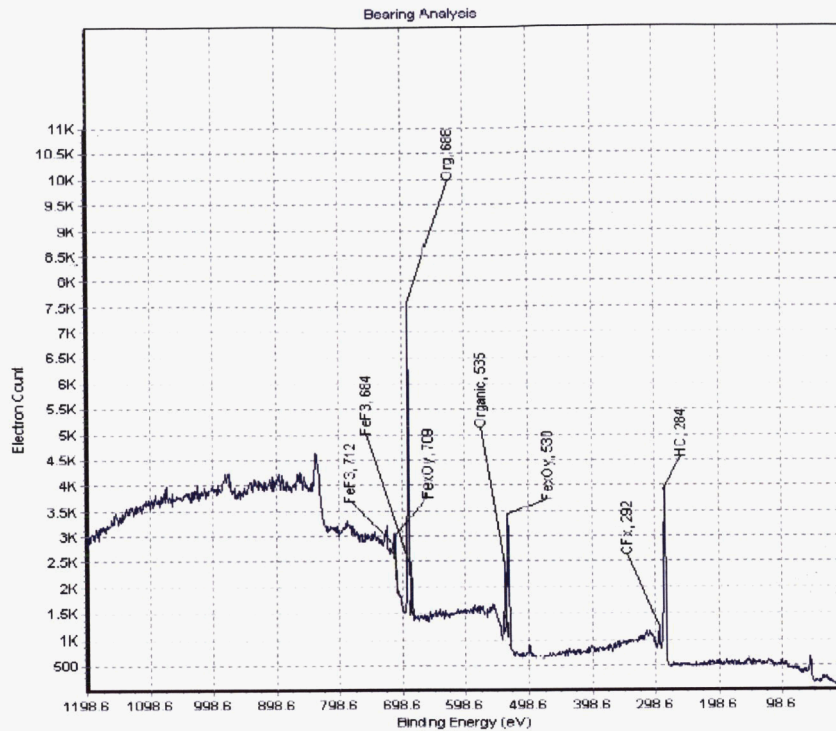
XPS was performed on the black ball at three different locations and on the inner race. Following the initial scans, depth profiling was performed by application of fifteen sputtering cycles, each lasting ten seconds, and a total sputter time of 450 seconds per location. The results show a carbon-rich coating on top of an iron oxide-rich surface. The carbon-rich top surface forms during the tribological decomposition of Braycote 601 grease and contains fluorine and sodium from the grease [7, 8]. The Raman spectrum of the carbon-rich coating is reported in the Raman spectroscopy section. Below the carbon-rich coating is the black tribological iron oxide-rich coating that also contains fluorine from the grease. At the end of the sputtering cycles, sodium was no longer present and chromium was observed in both locations in addition to carbon oxygen, fluorine, and iron (Figure 10).

Figure 10. An XPS spectrum for black ball

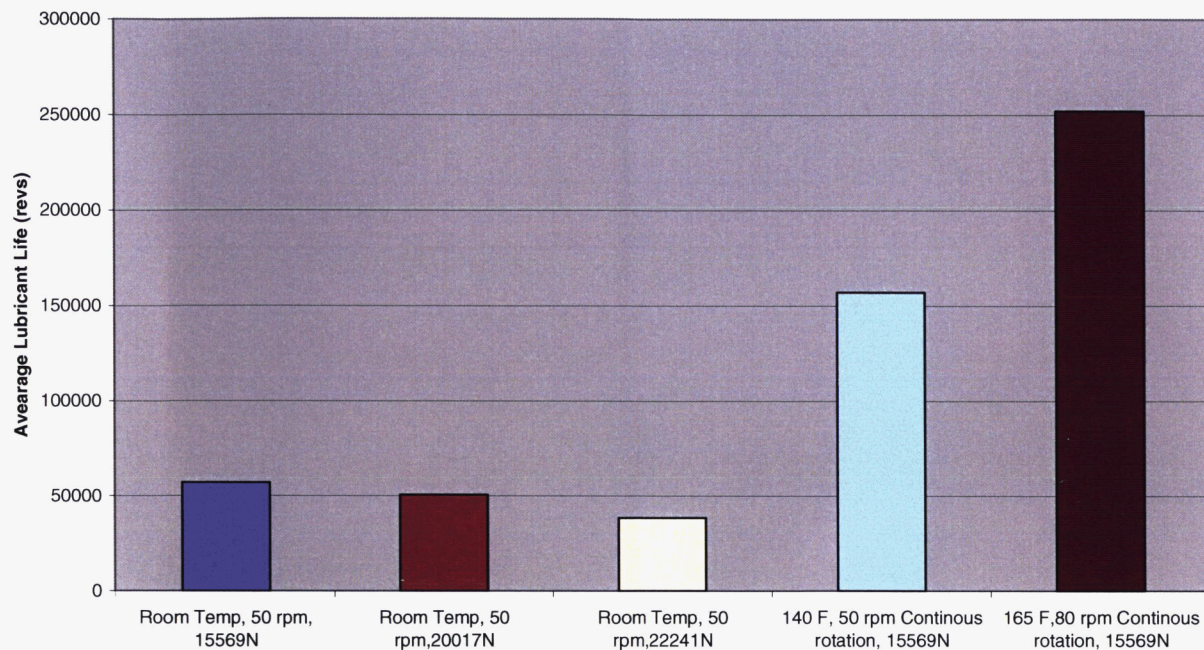
Figure 20. The effect of temperature on lubricant life

The results of this testing indicated that temperature had a significant effect on bearing life. Increased temperature yielded a significant increase in bearing life. The cause of this effect has not been determined. One theory is the higher temperature afforded better lubrication either by a decrease in apparent grease viscosity or by an increase in oil separation rate. This resulted in more oil available in wear contact area thus extending bearing life.

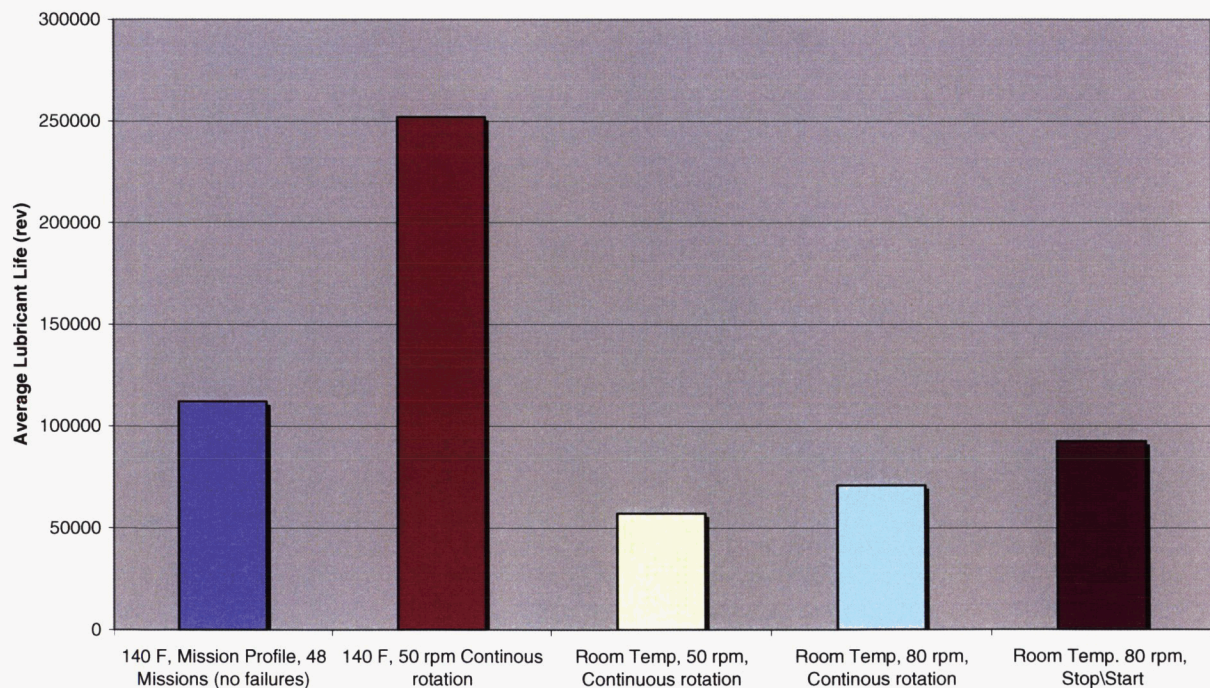
Figure 21. Results of start\stop lubricant life testing

The start\stop testing at 80 rpm most closely simulated the actual BFA operation. The majority (92%) cycles on the BFA are applied during ground operation under stop\start conditions. All of these cycles occurred at 80 rpm with 15569-N axial load at room temperature. The remaining cycles occurred during flight. The BFA was never operated under maximum load (22241-N load). This load occurred during ascent when the actuator is in a lock position. The actuator was operated for several seconds in space to test the actuator, but the remainder of cycles occurred during re-entry where temperature probably
